Aqualogic [®] Inc.

Acid Etch Line

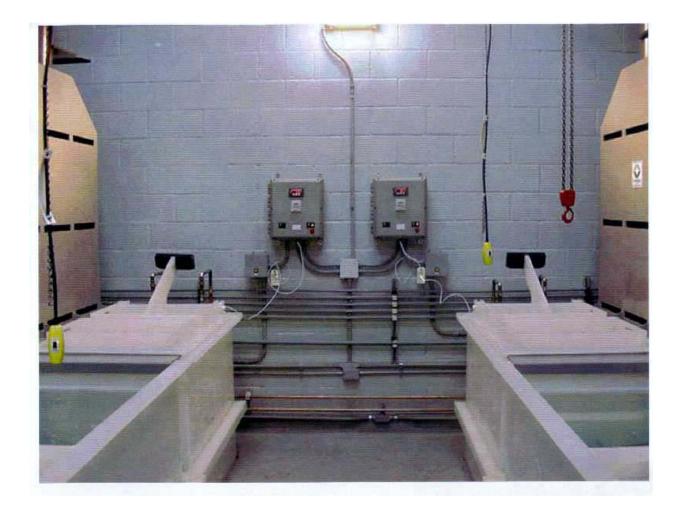
Installed in a turbine repair facility for processing high temperature alloys. Note the counterbalanced covers on acid processing tank to minimize fumes from hot $(140^{\circ}F)$ concentrated Hydrochloric Acid
